# TECH MANAGEMENT, INC.

*Consulting To The Construction Industry*

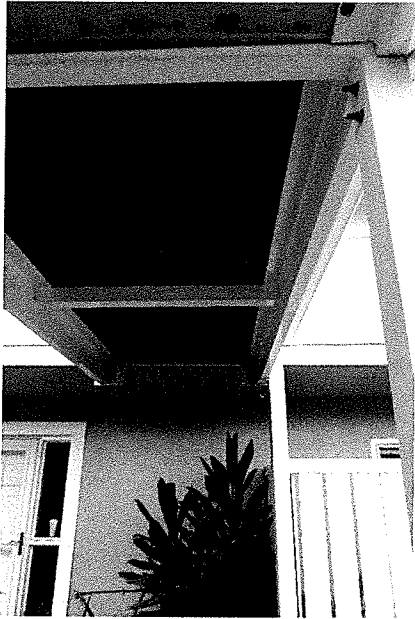
P 5: Rust Underneath Walkway

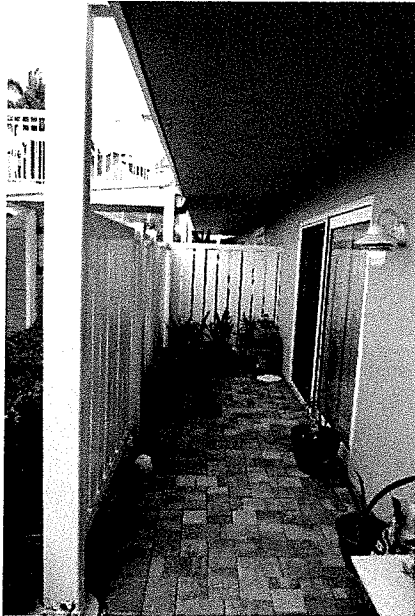
P 7: First Floor Patio

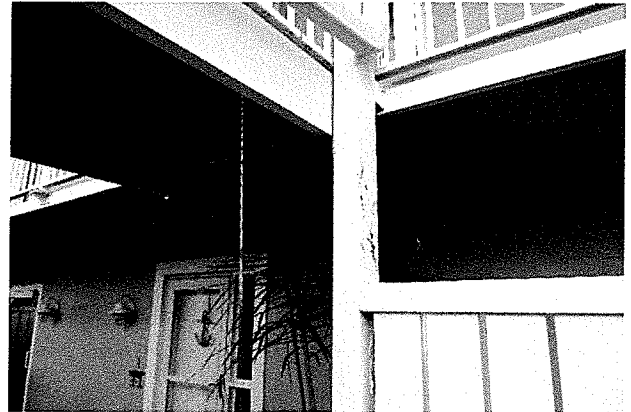
P 8: Rust & Deteriorating Coating

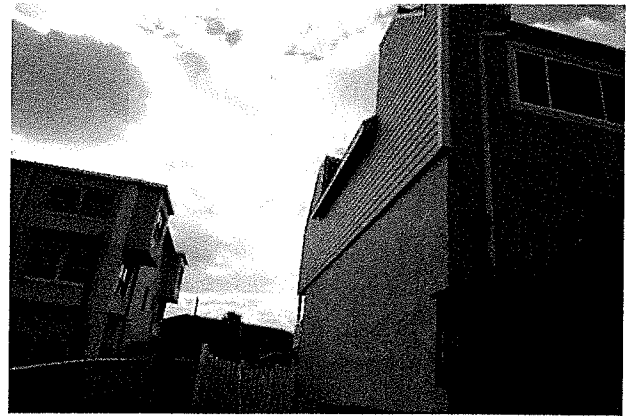
P 10: Elevation; North Building, Northside

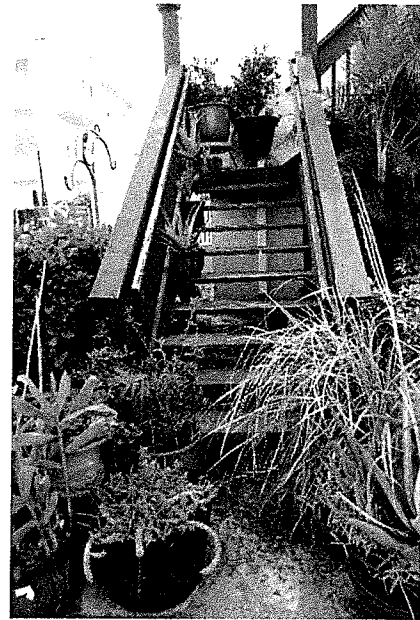
P 12: Deteriorating Wood Stairwell, West Elevation

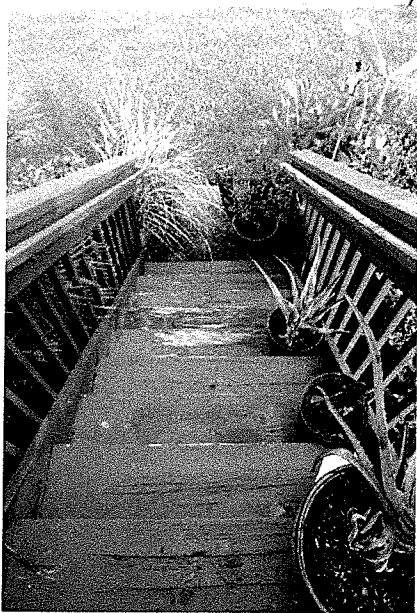
P 13: Deteriorating Wood Stairwell, West Elevation

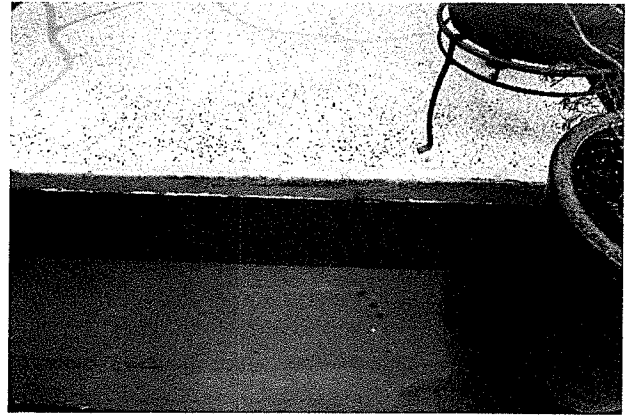
P 14: Deteriorating Wood at Landing, West Elevation

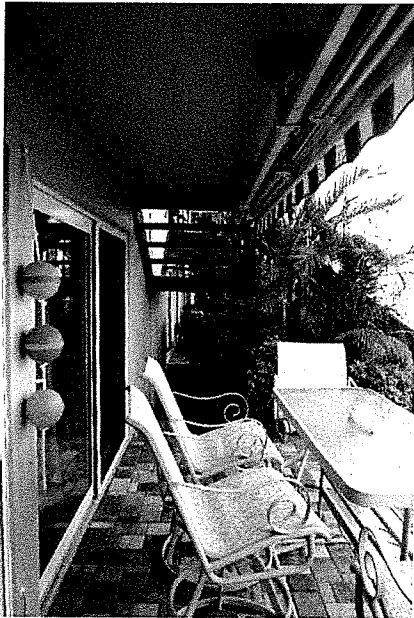
P 15: First Floor Rear Patio, West Elevation

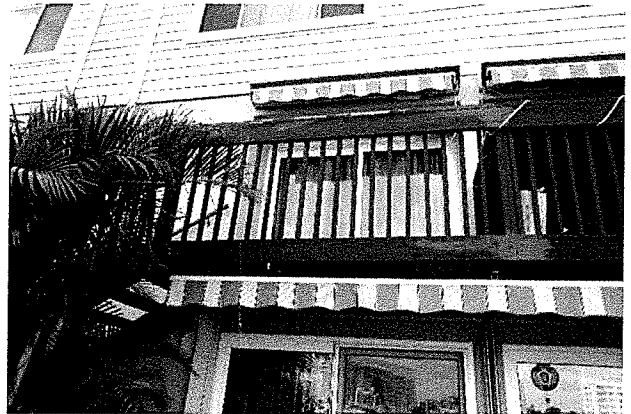
P 16: Deteriorating Wood Railing, West Elevation

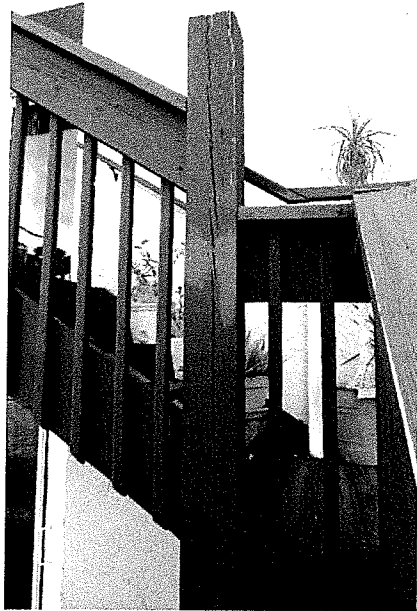
P 17: Split Post, West Elevation

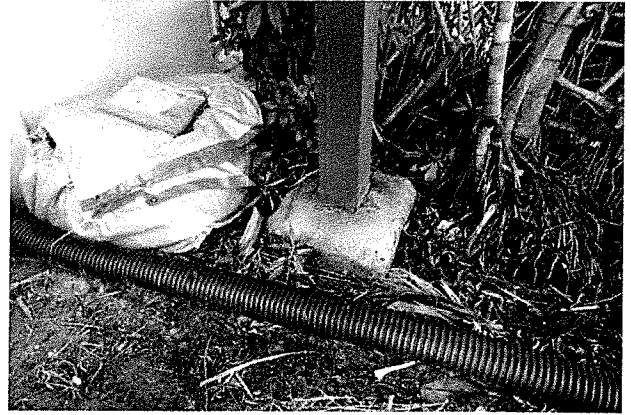
P 18: Deteriorating Concrete Base, West Elevation

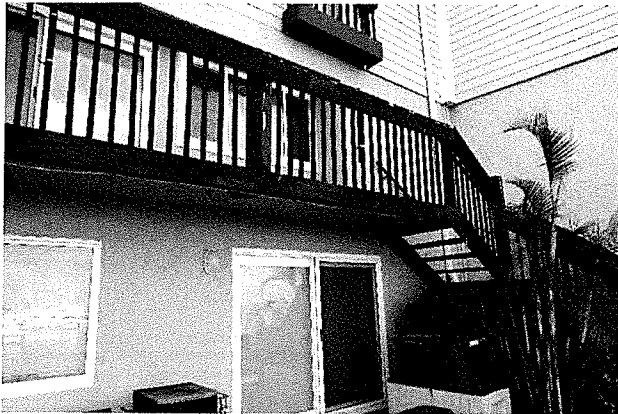
P 19: Deteriorating Wood Railing, West Elevation

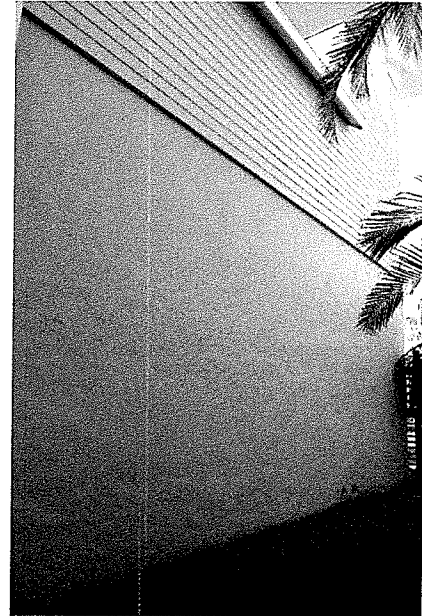
P 20: Elevation; South Building, Southwest Corner

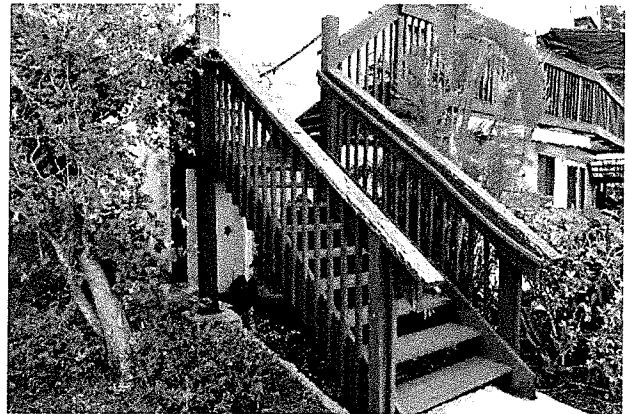
P 24: Deteriorating Wood Railing, West Elevation

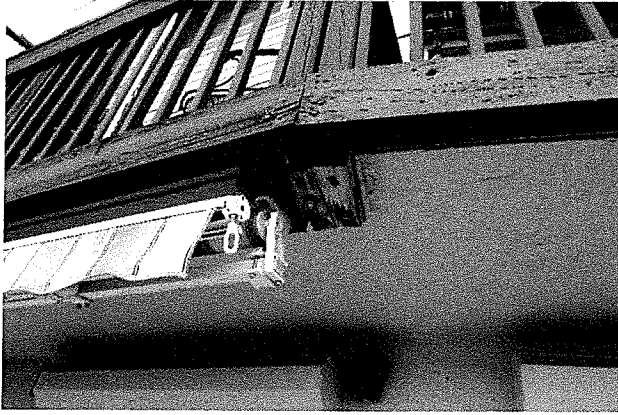
P 25: Wood & Fastener Damage, South Elevation

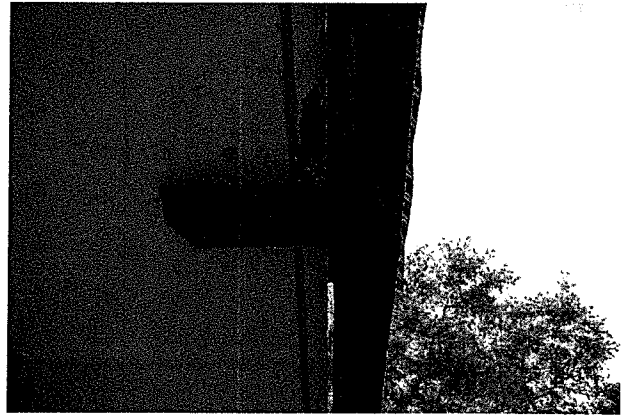
P 26: Concrete Spall & Exposed Steel, South Elevation

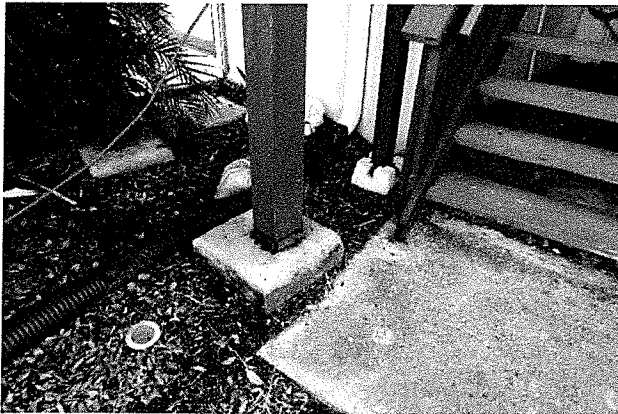
P 27: Rust at Concrete Base, South Elevation

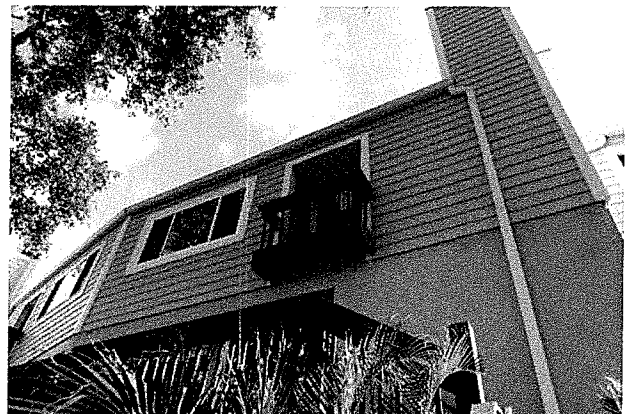
P 28: Uncoated Wood at Balcony, South Elevation

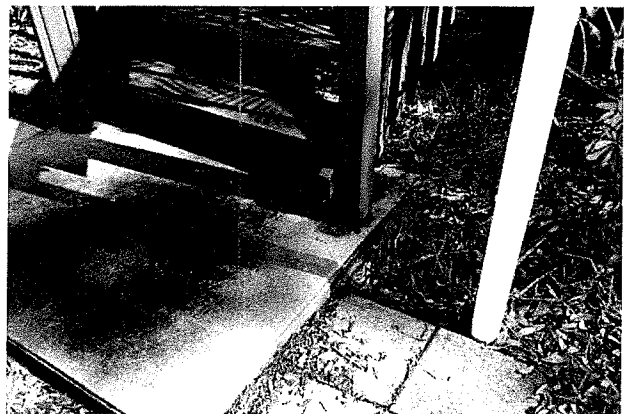
P 32: Moisture Damage at Stairwell, South Elevation

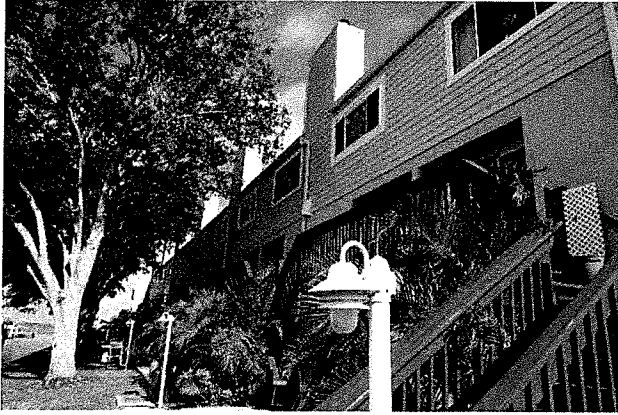
P 33: South Elevation, South Building, Southeast Corner

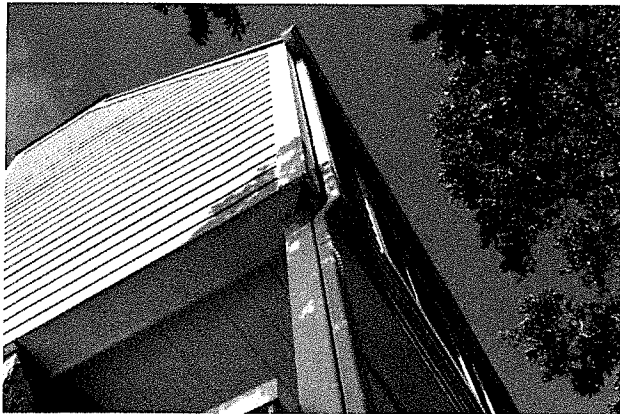
P 35: Missing Wood Beam, East Elevation

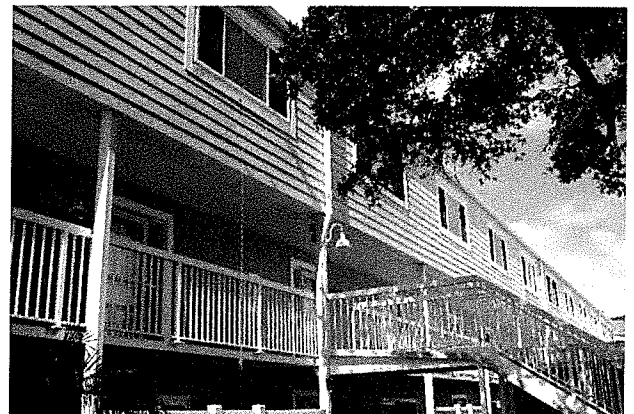
P 36: Drain; North Elevation, South Building

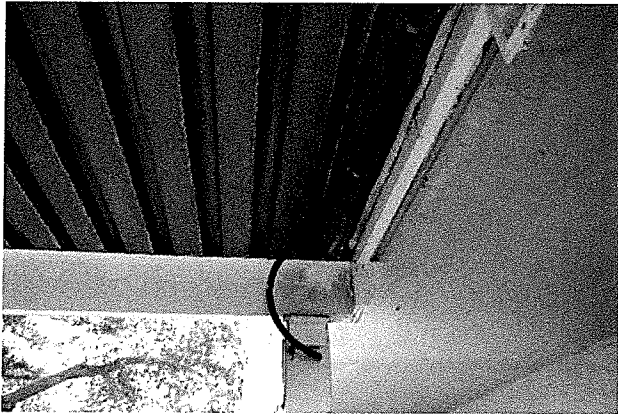
P 37: Rusted Steel underneath Walkway; North Elevation, South Building

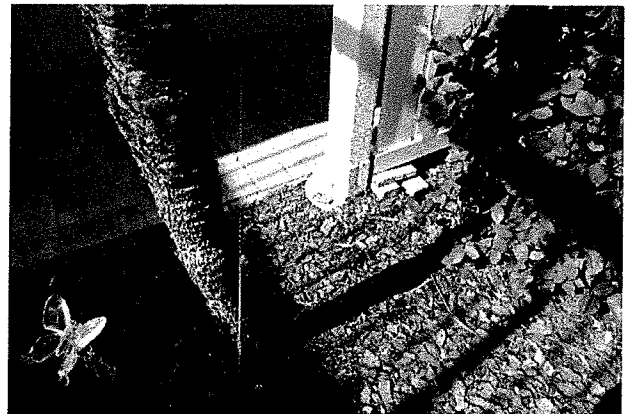
P 38: Rusted Steel Base; North Elevation, South Building

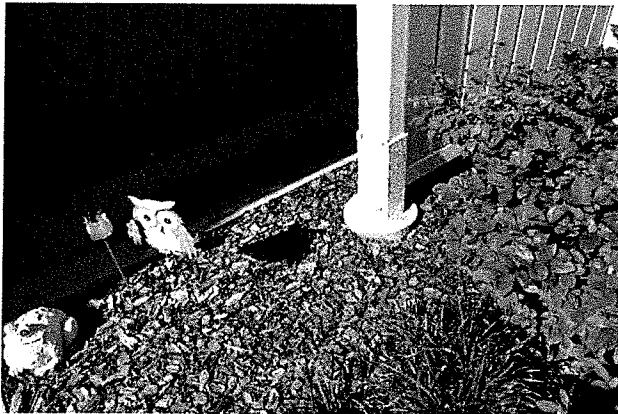
P 39: Rusted Steel Base; North Elevation, South Building

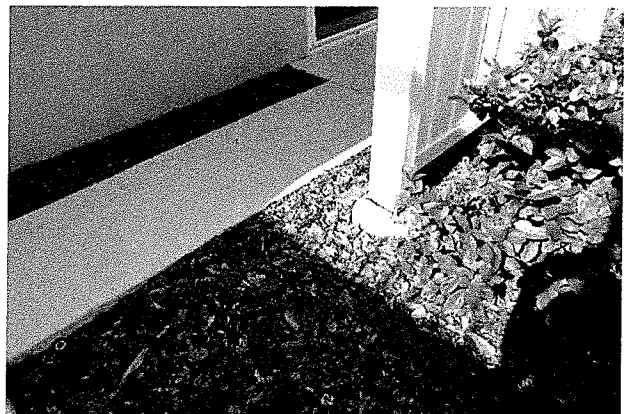
P 40: Rusted Steel Base; North Elevation, South Building

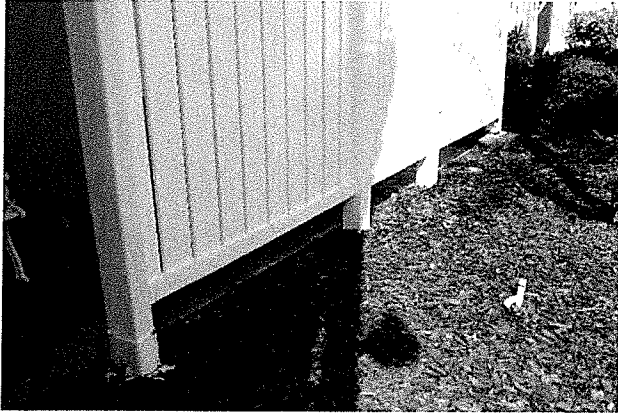
P 41: Rusted Steel Base; North Elevation, South Building

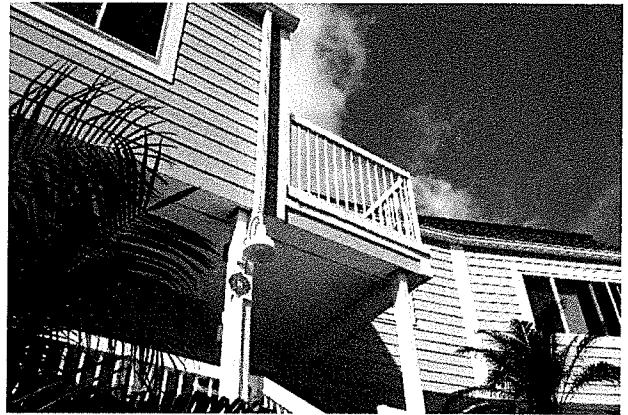
P 42: Damaged Wood at Balcony Railing; North Elevation, South Building

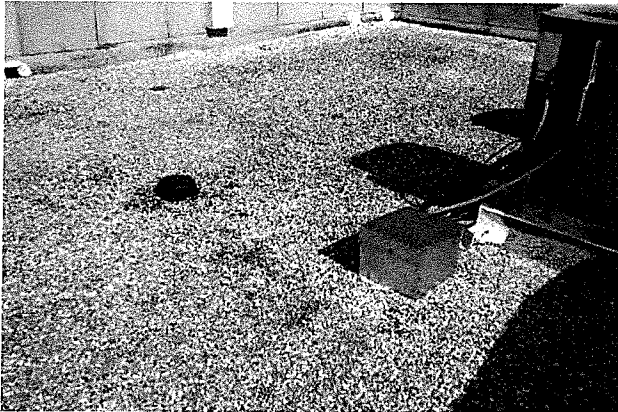
P 43: North Building Roof, at Sout East Corner

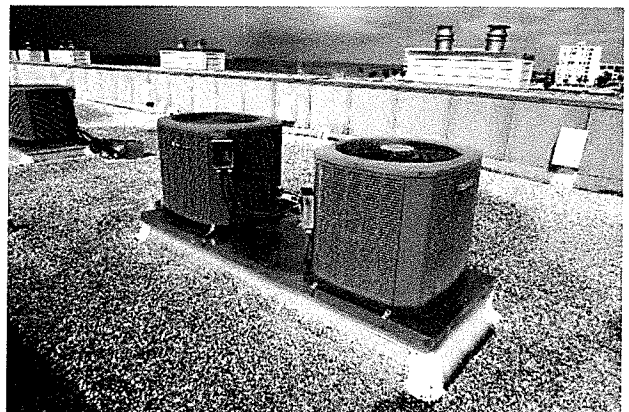
P 48 Rusted A/C Units with L-Fasteners

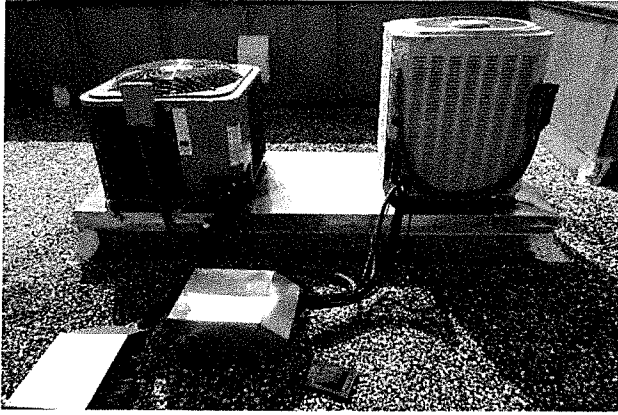
P 49: A/C Units with L-Fasteners

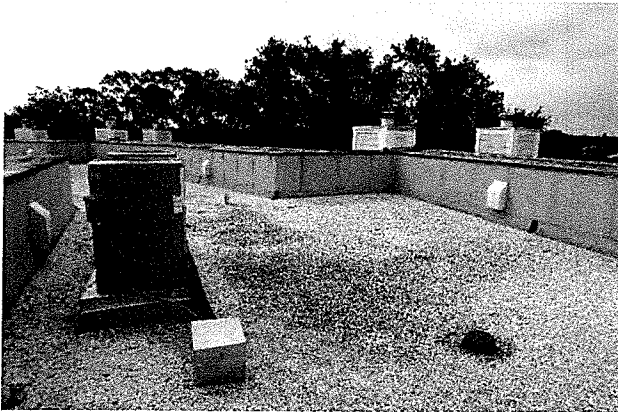
P 51: South Building Roof, at Northwest Corner

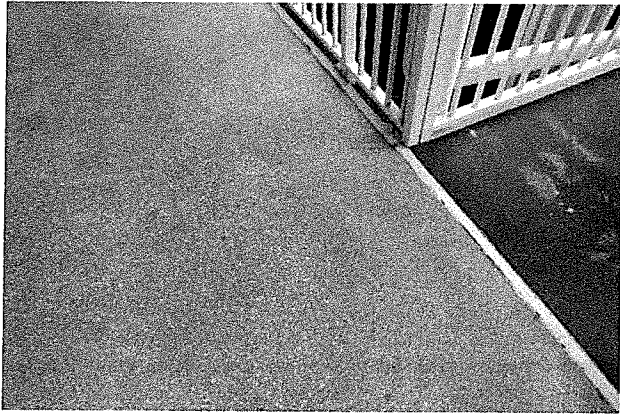
P 85: Rusted Joint, Elevated Walkway

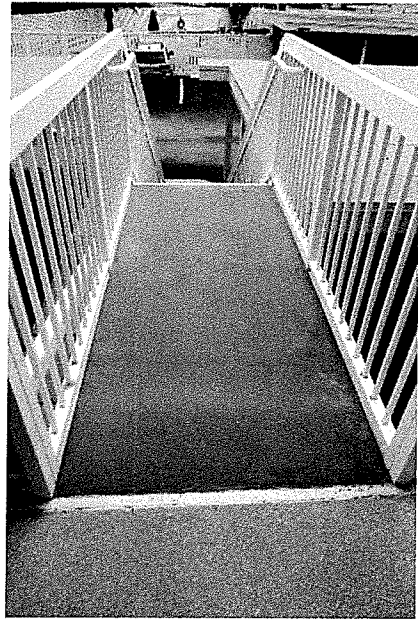
P 86: Rusted Joint & Stairwell Walkway

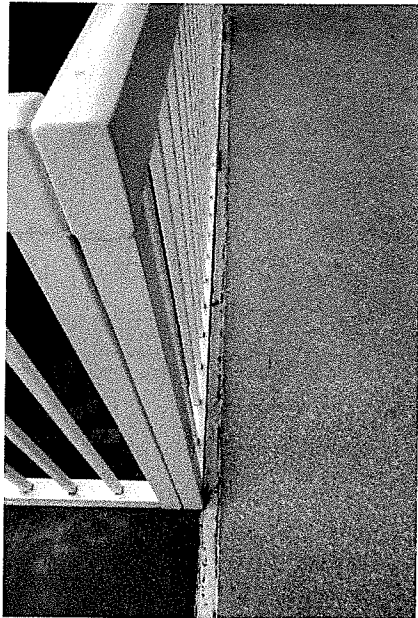
P 87: Rusted Steel, Elevated Walkway

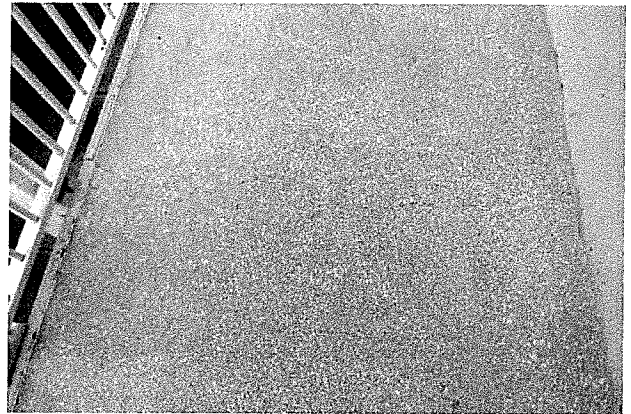
P 88: Concrete Crack, Elevated Walkway

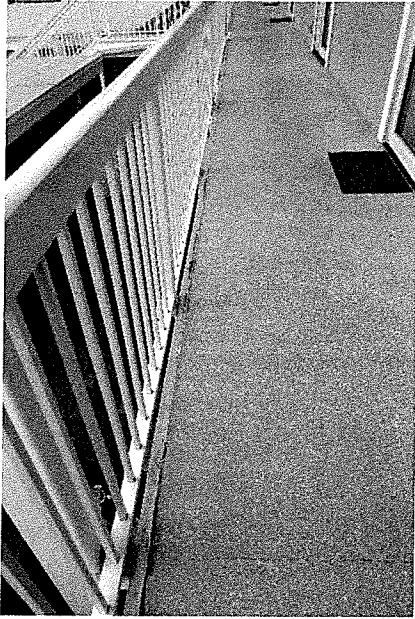
P 89: Rusted Steel, Elevated Walkway

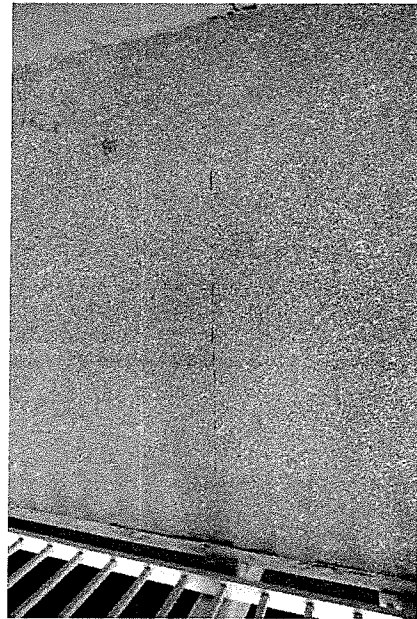
P 90: Concrete Crack, Elevated Walkway

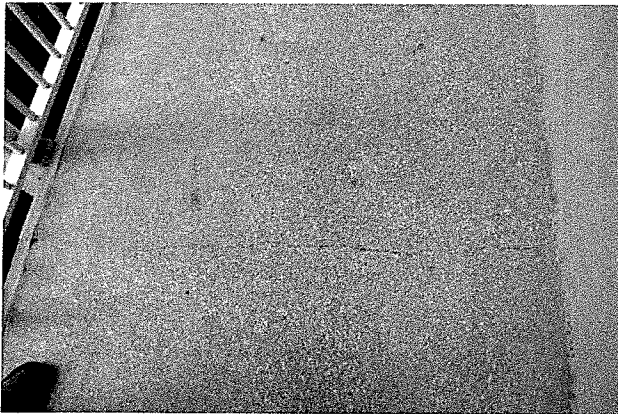
P 91: Concrete Crack, Elevated Walkway

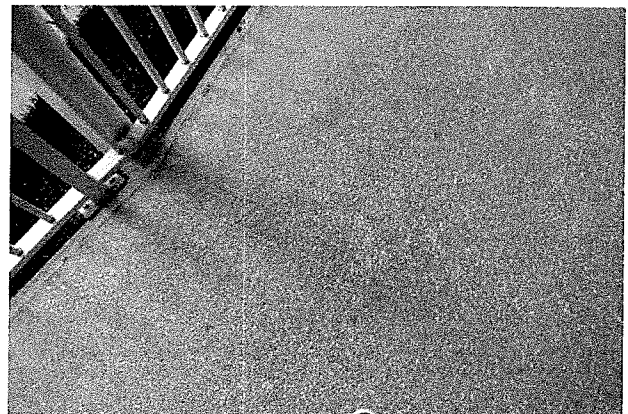
P 92: Concrete Crack, Elevated Walkway

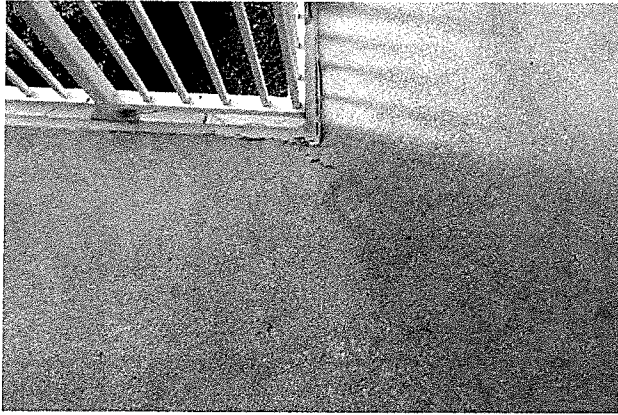
P 93: Concrete Spall, Elevated Walkway

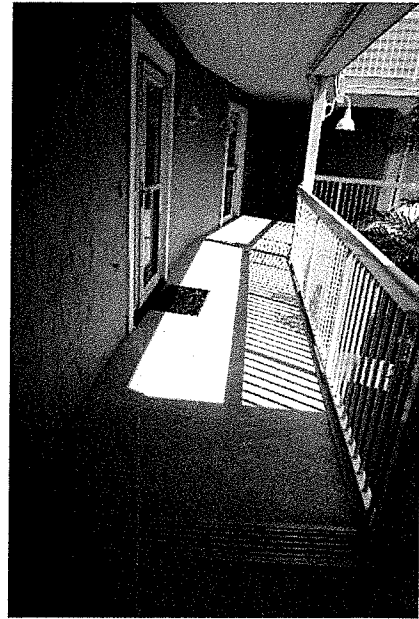
P 94: North Building Elevated Walkway, at Elevator

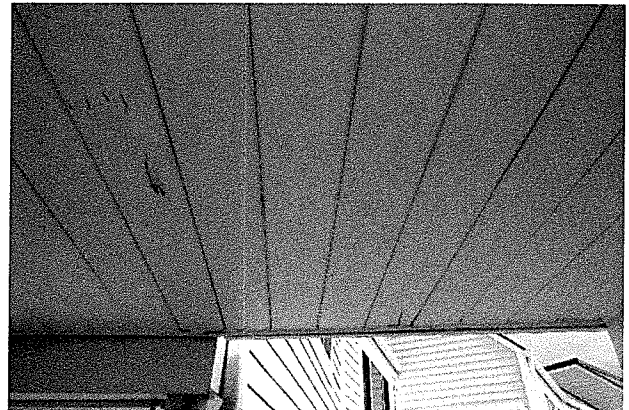
P 96: Damage Ceiling Panels, Elevated Walkway

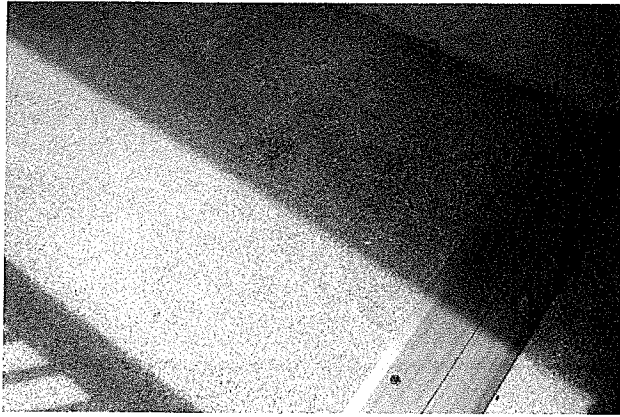
P 97: Concrete Spall, Elevated Walkway

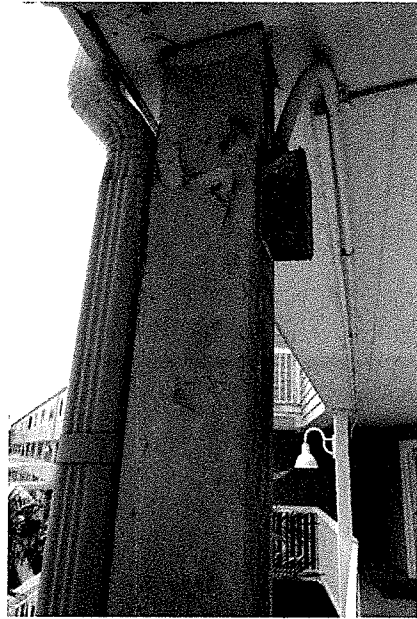
P 98: Rusted Support & Deteriorating Coating,  
Elevated Walkway

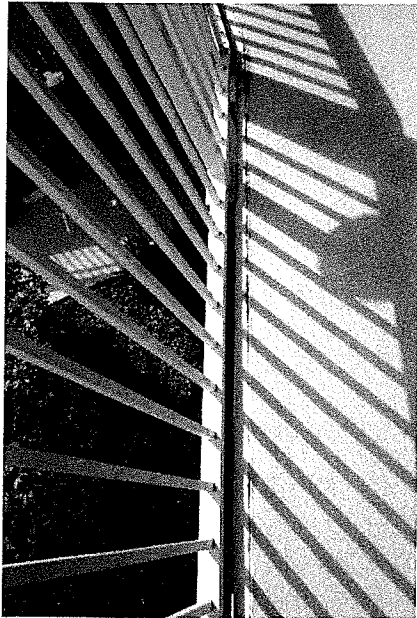
P 99: Rusted Steel, Elevated Walkway

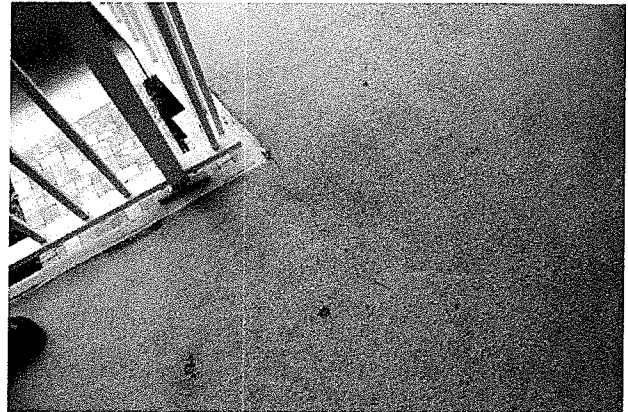
P 100: Rusted Steel & Concrete Crack, Elevated  
Walkway

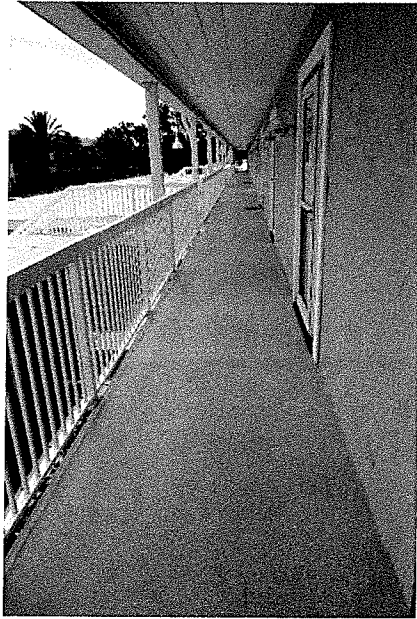
P 101: South Building Elevated Walkway, at Westside facing East

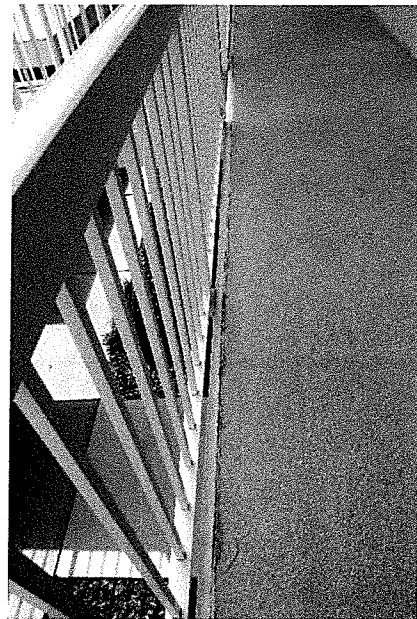
P 102: Rusted Steel, Elevated Walkway

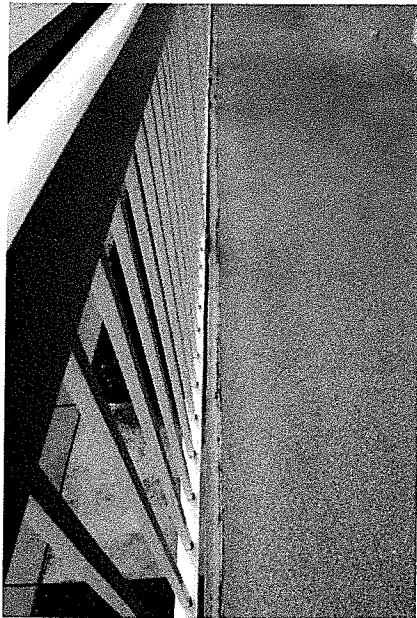
P 103: Rusted Steel, Elevated Walkway

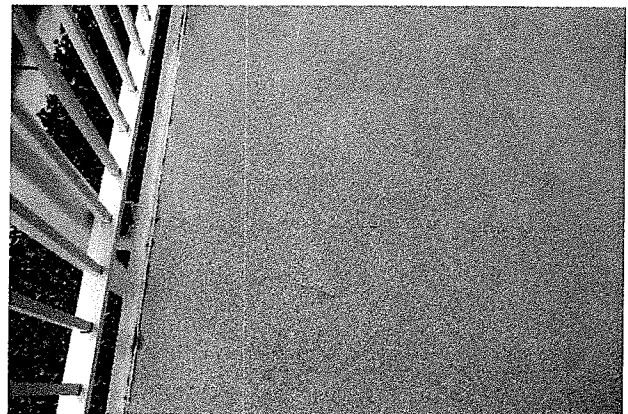
P 104: Concrete Crack, Elevated Walkway

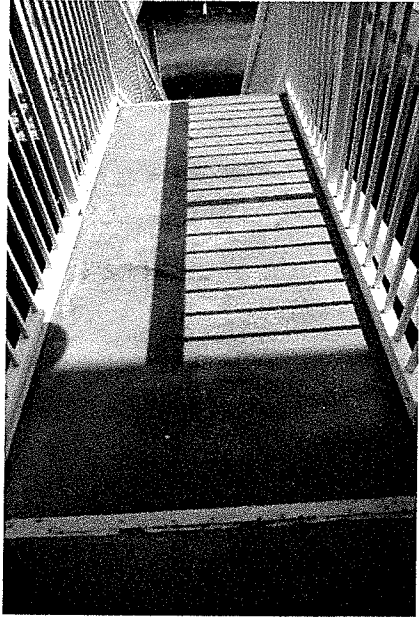
P 105: No Coating on Stairwell Walkway

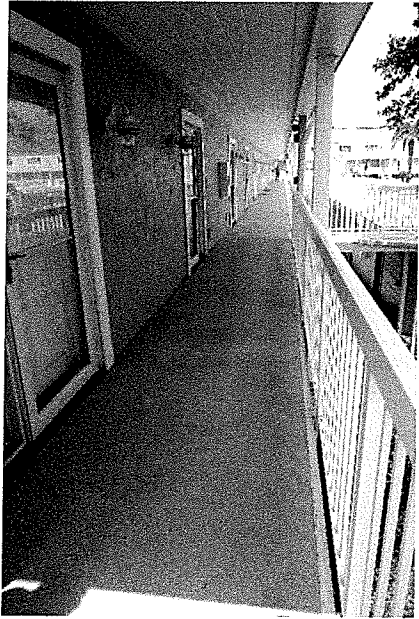
P 109: South Building Walkway, at Eastside facing West

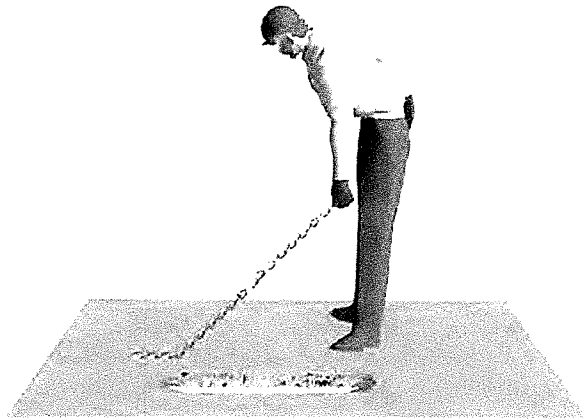
*Fig. 1—Sound the concrete surface to locate delaminated areas. Chain drags can be used for sounding.*

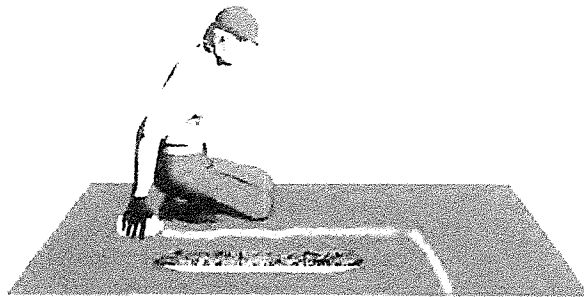
*Fig. 2—Mark the perimeter of the repair area using simple geometric shapes and minimizing re-entrant corners.*

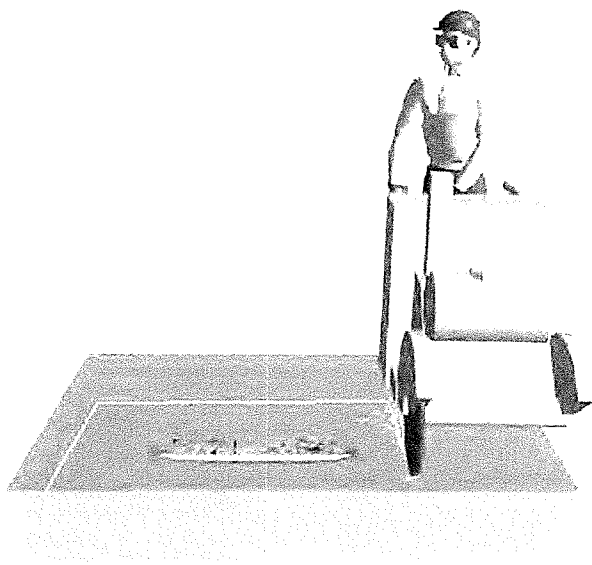
*Fig. 3—Sawcut the repair perimeter, but no deeper than the thickness of the concrete cover over the reinforcement.*

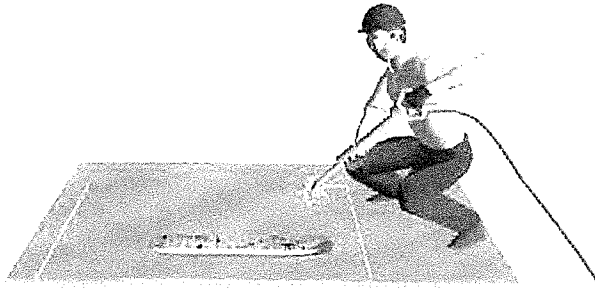
Fig. 4—Initial concrete removal within the sawcut area, using a 15- or 30-lb jackhammer. Use 15-lb jackhammer for final removal.

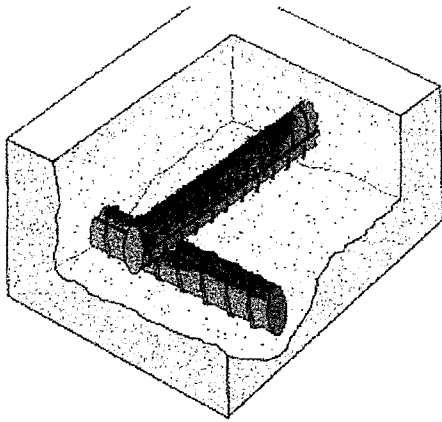
Fig. 5—If corrosion is present, remove enough concrete to fully expose the corroded bar.

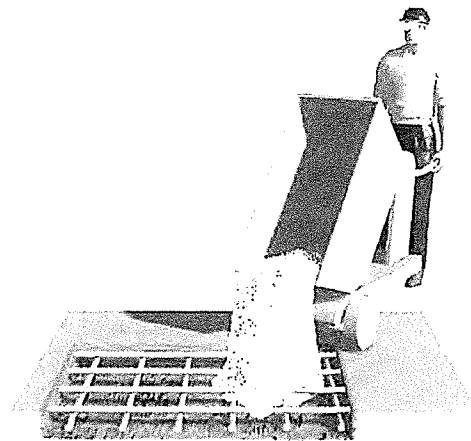
Fig. 8—Place repair material into the prepared cavity by buggy, pump, or other conveying method.

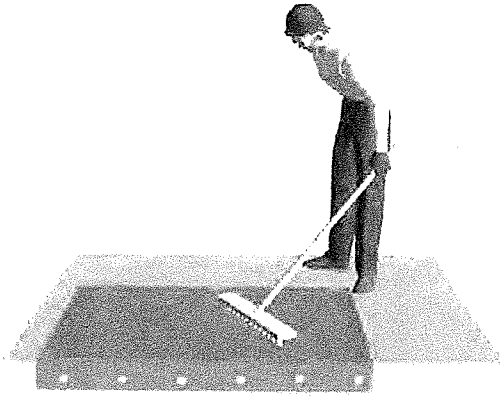
Fig. 9—Strike off, then float the repaired surface.

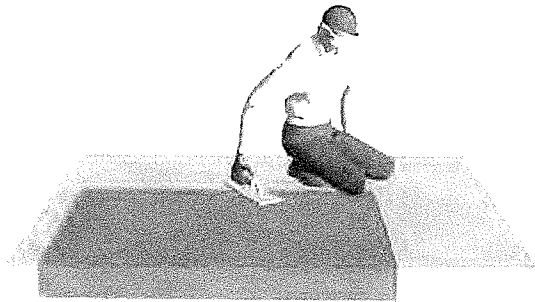
Fig. 10—After floating, trowel or broom the surface.

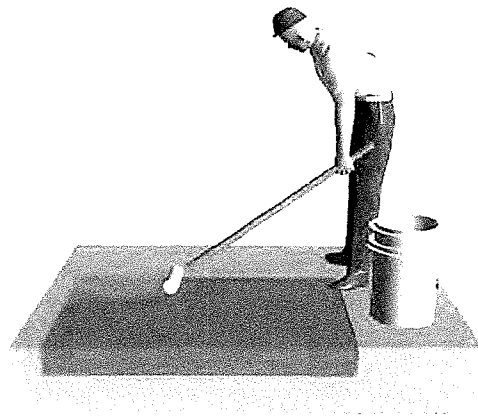
Fig. 11—Cure with wet coverings, or use a spray- or roller-applied curing compound as shown here.

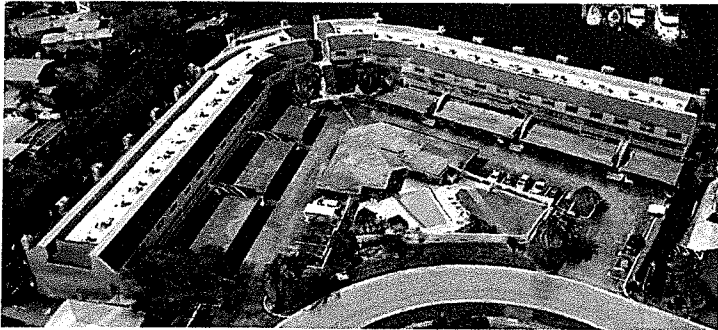
AERIAL FRONT VIEW  
SCALE: N.T.S.

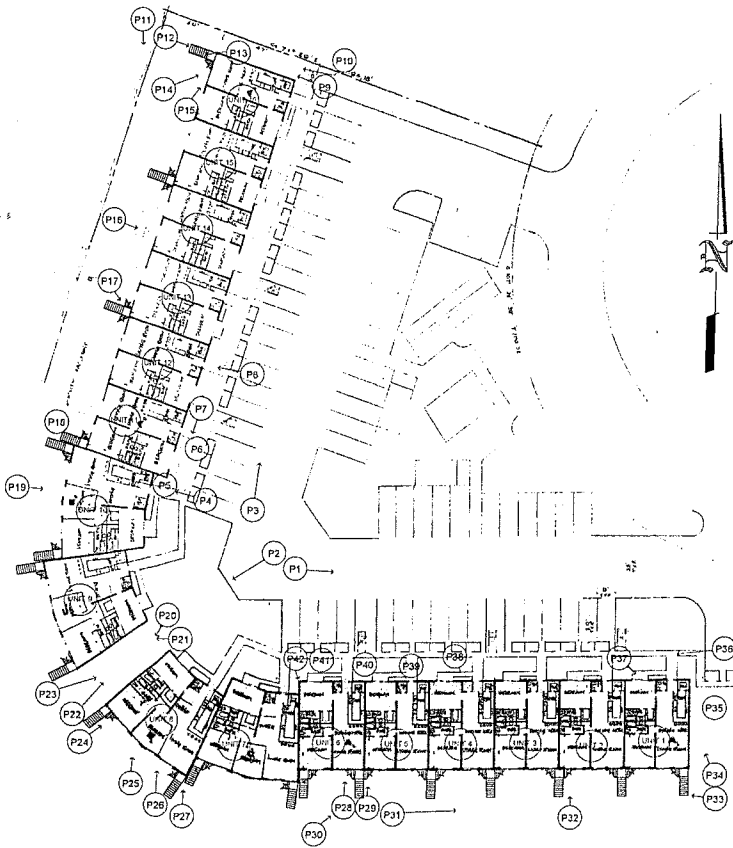
FIRST FLOOR PLAN  
SCALE N.T.S.

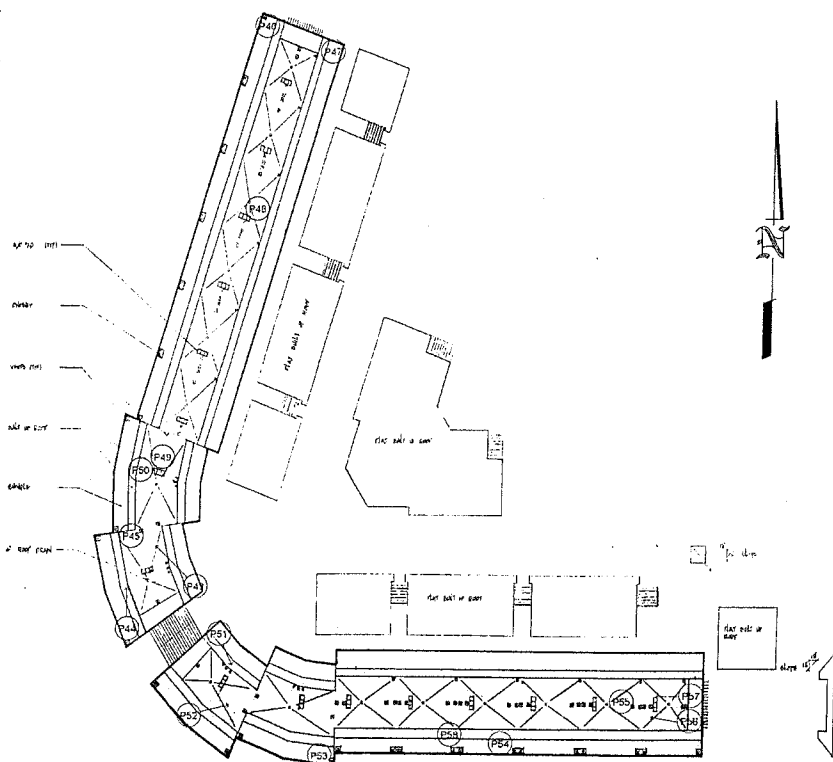
ROOF PLAN  
SCALE: N.T.S.

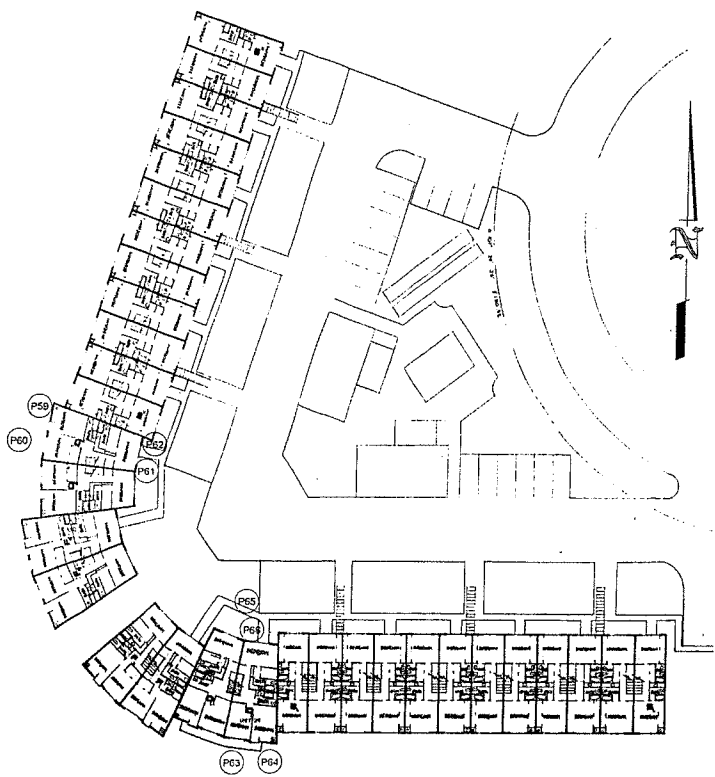
THIRD FLOOR PLAN  
SCALE: N.T.S.
